## INCREASING THE ENERGY PERFORMANCE OF IRON GATES I HPP THROUGH REFURBISHMENT AND UPGRADING ACTIVITIES

*The refurbishment and upgrading of the Iron Gates I HPP equipment represents, due to the technological complexity and investment effort, the most important and successful project of its category in the Romanian hydro energy system.*

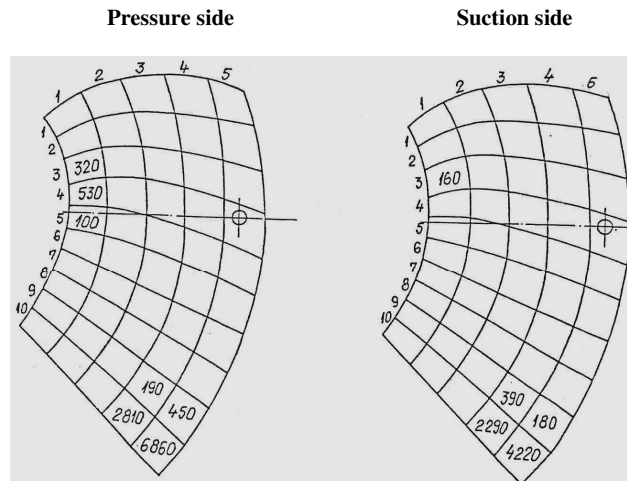
- *cavitation* in specific areas on the suction side with depths till 20 mm;
- *cracks* in two specific areas (see Figure 1), more precisely blade axis to coupling flange with the hub and the outlet area towards the runner chamber. At unit 6, in 1989, parts of around 460x490 mm<sup>2</sup> broke at blades no 2 respectively no 5, in the outlet area, where the thickness is the smallest.

Fig. 1. Cracks distribution on the blade – Total lengths [mm] HU1-HU6 all the checks from PAC until 1996.

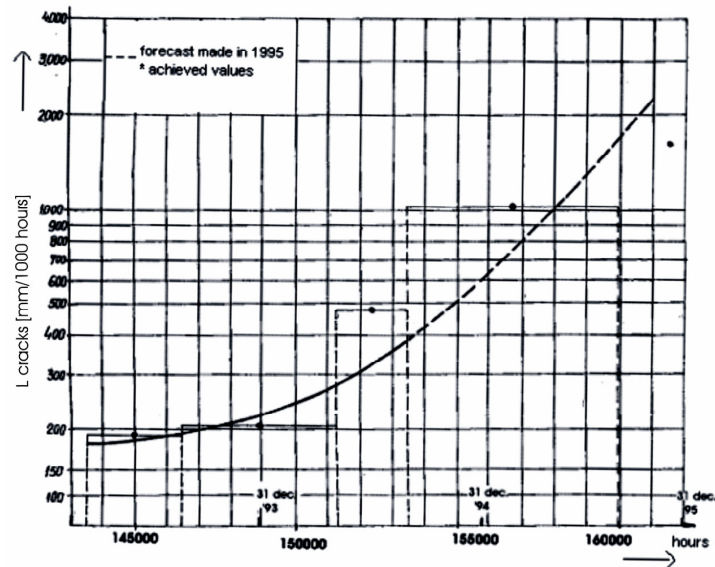
In Figure 2 the timely evolution of the speed development of cracks on old blades (in mm/1000 operation hours) at all 6 units from the commissioning until 1996 is presented.

This graphic clearly presented that the blades were in an accelerated degradation process and were getting closer to the maximum number of solicitation cycles, meaning the expiration of lifetime.

Fig. 2. Timely evolution of cracks speed development.

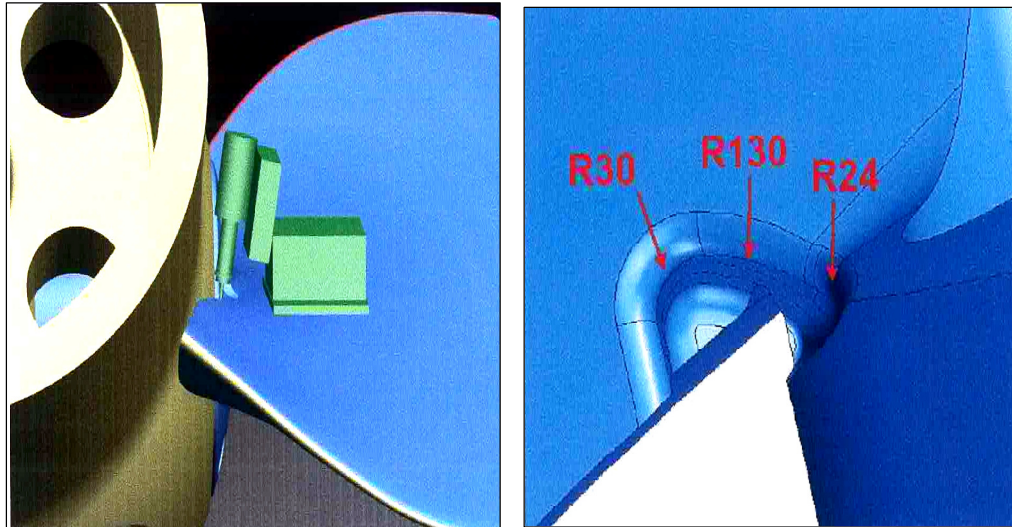
Fig. 3. Stress Relief Groove – execution and geometry.

Subsequently, during 2005, the blade's geometry was improved by eliminating the maximum stress area from the connection of the pressure side of the blade with the flange, towards the inlet, by implementing a stress relief groove (see Fig. 3.). In this groove, a demountable, bronze "filling piece" was introduced, not to modify the blade's geometry.

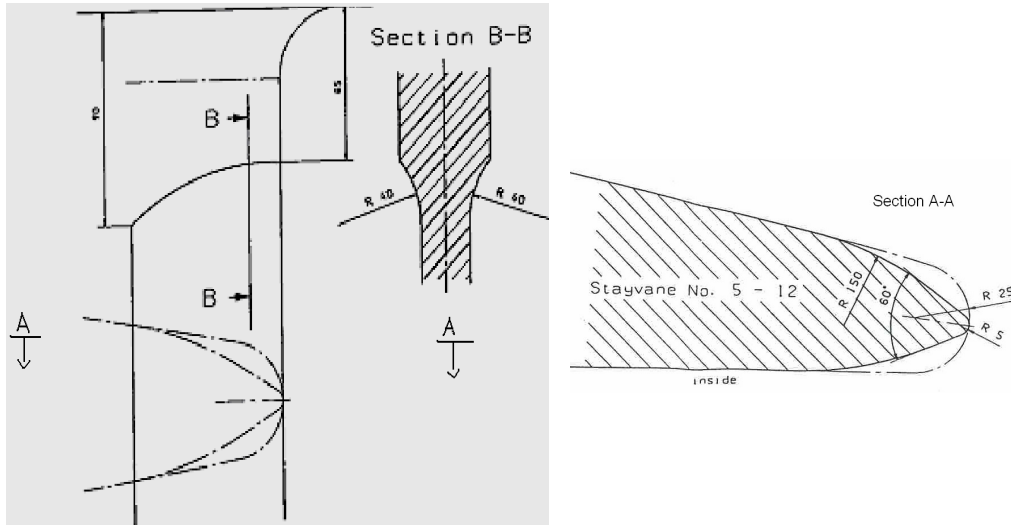
⇒ **The stator:** At 10 from the 12 stay vanes, cracks appeared in the joint welds with the inferior and superior ring. As a general rule, these cracks (that also

appeared in the units from Djerdap I HPP from Yugoslavia), once repaired, would never appear in the same place, but in adjacent areas.

Fig. 4. Stay vane – Modification at outlet edges.

⇒ **Modification of the outlet edges profile of the stay vanes** in order to reduce the amplitude of the hydraulic vibrations and the risk of the cracks.

These modifications were done on site, and up to now, (after approximately 7 years from the commissioning of the first unit) no other cracks appeared.

In Figure 4 the new geometry of the outlet edges of the stay vanes is presented.
