## IRON GATES II – ROMANIA, 10 BULB UNITS UPGRADING

*At Iron Gates II Hydro Power System (HPS), the modernization of 10 large bulb units is almost in the middle of the contract execution and first feed-back can be provided. This publication deals with an overview on the past and present activities as well as results and experiences related to the upgrading and modernization of these ten bulb units. Focus is given on the turbine, the generator, on the Automation, Control and Protection systems (ACP) and on the operation of the whole power plant while modernization works are being performed.*

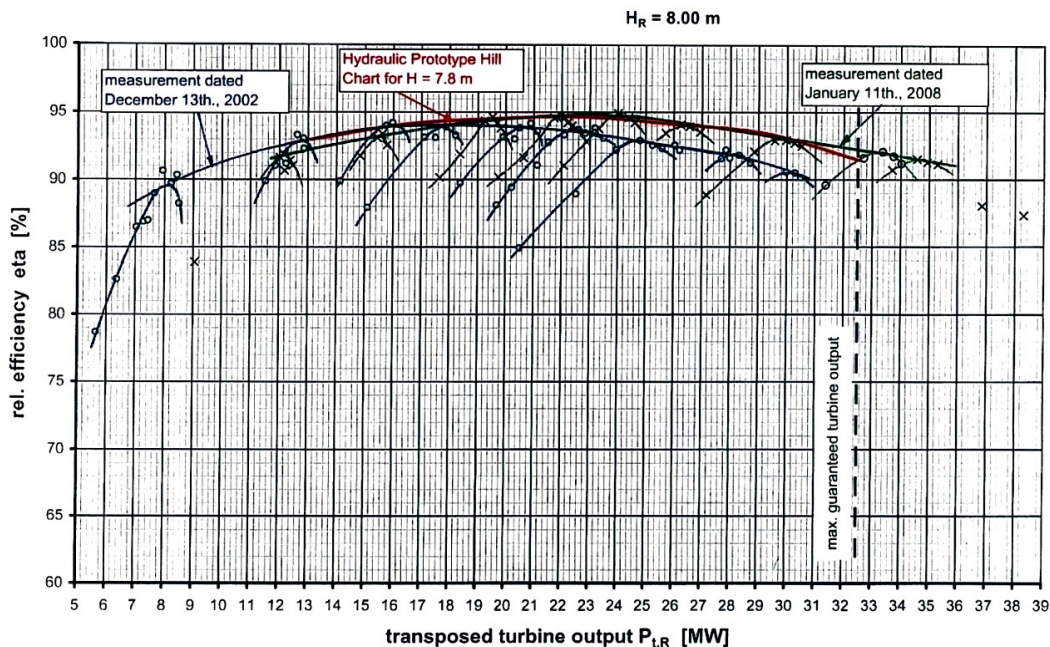
The cavitation inspection after 8000 hours of operation at three units until now, confirmed the cavitation behavior on the model test – no signs of cavitation erosion. Index measurements were done before and after rehabilitation in order to verify the improvement potential achieved by the overhaul and replacement. The measured maximum output amounted to 35.46 MW and the new guaranteed for turbine output of 32.5 MW was exceeded significantly by 9% (see Figure 3).

Fig. 3. Efficiency and power output improvement at rated head

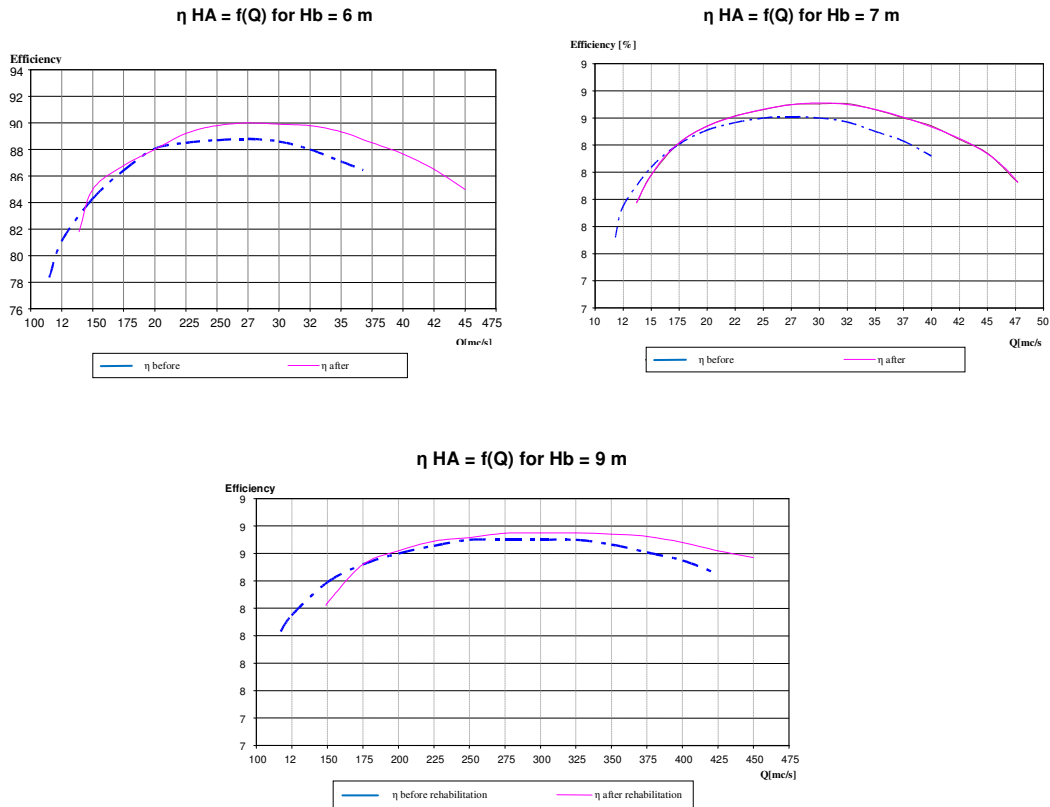
For the significant range of gross head  $H_b$  the efficiency of the refurbished Unit (HA) is bigger than the original one. An example for three gross heads is showed in Figure 4.

Fig. 4. Efficiency improvement at different gross head

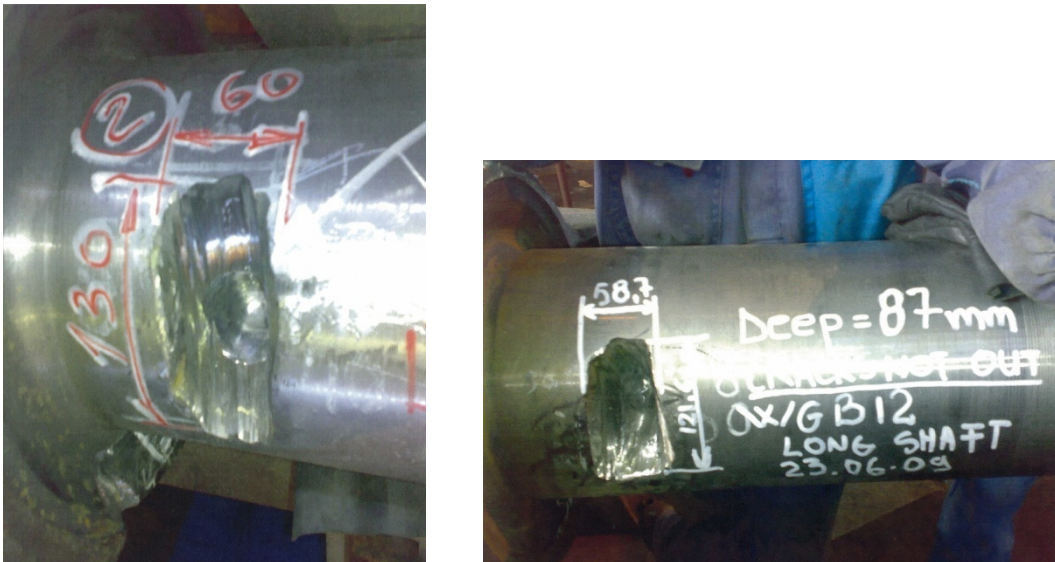
After dismantling the parts (turbine and generator), a NDT examination is performed. The bad condition of many parts (e.g. turbine shaft, guide vane, turbine servomotor piston, thrust bearing pads, generator hub) proved the necessity of the rehabilitation. Only for example, at the 5<sup>th</sup> unit that is in the process of rehabilitation now, all trunnions of the guide vane showed cracks in the welding area between guide vane and trunnion (see Figure 6).

Fig. 6. Excavation on guide vanes long trunnions

Additional unexpected refurbishment measures must be taken in this case. The guide vane must be transported in the factory, the trunnions were cut off and new trunnions were welded to the guide vane bodies. This bad condition of the above mentioned parts was partly caused by the poor original fabrication and quality test methods applied at that time and partly by wear during the time of operation. The parts are also on the critical path of the execution schedule with time impact. For these reasons, to reduce the time impact and the cost with time impact the decision was taken to order the fabrication of new parts (e.g. one new

turbine shaft, two new turbine servomotor piston, one new generator hub and two new guide vanes).
