## IRON GATES II – ROMANIA, 10 BULB UNITS UPGRADING

*At Iron Gates II Hydro Power System (HPS), the modernization of 10 large bulb units is almost in the middle of the contract execution and first feed-back can be provided. This publication deals with an overview on the past and present activities as well as results and experiences related to the upgrading and modernization of these ten bulb units. Focus is given on the turbine, the generator, on the Automation, Control and Protection systems (ACP) and on the operation of the whole power plant while modernization works are being performed.*

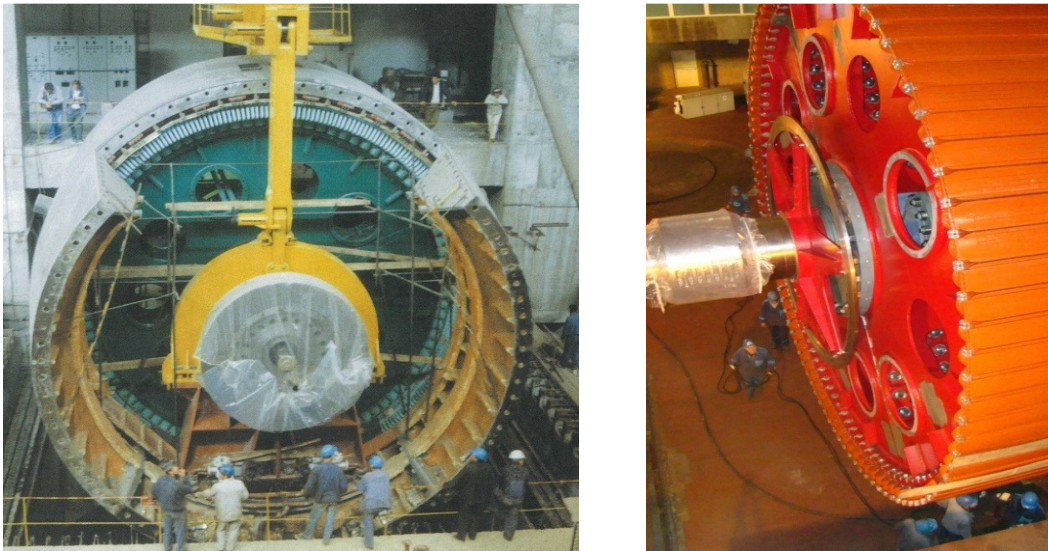
Fig. 5. Generator stator and rotor

As a consequence of damage for the shrinking coupling during the operation, two hubs to the generator rotor (generators no. 3 & no.7) and one generator shaft (generator no.3) are also provided as replacement works. The shrinkage between hub and shaft will be checked at all generators, specifically due to the new power increase.

The rotor poles must be dismantled from the rotor rim, must be inspected, tested and reconditioned. The replacement of main insulating is provided, if this one was heated up. The checking and repairing for all circuits (cooling water circuits and electrical circuits) is also provided.

The stator winding has to be inspected and to follow a set of tests and checking. The diagnose program has as purpose to establish the status of the insulation and its life cycle. The works include the replacement of defect bars during the tests, repainting of varnishing, cleaning of the cooling water system by distilled water, the replacement of Teflon tubes, the checking and repair of the circuits (water circuits and electric circuits).
