# NEW METHODS TO COMBAT THE EXCESS DEVELOPED VEGETATION INTO THE HYDROPOWER LAKES

## Victorita RADULESCU<sup>1</sup>, Dana Roxana HORHOIANU<sup>2</sup>, Z. ZETENYI<sup>3</sup>, Alexandra RADULESCU<sup>4</sup>

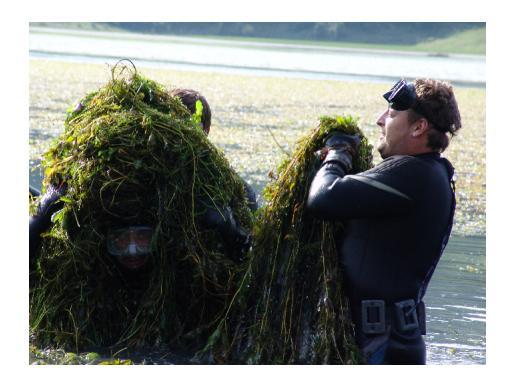
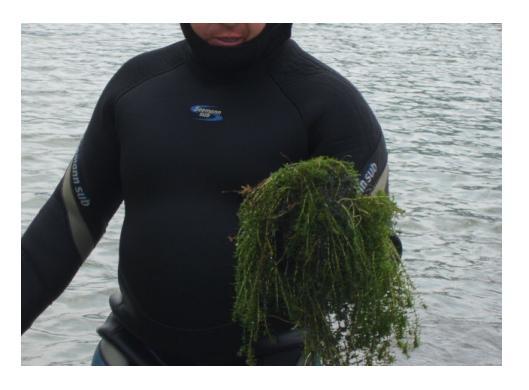
Fig. 1. Images during collecting vegetation from Pangarati Lake - Cladophora glomerata

By collecting vegetations from analysed lakes it may be observed that the populations is formed by types Achnanthes, Ceratoneis, Cocconeis, Cymbella, Diatoma, Fragilaria, Gomphonema, Navicula, Nitzschia, Rhoicosphaenia, Synedr and realise almost a green carpet under the free surface of lakes. Beside this diatomee there are and micro algae Oscillatoria, Phormidium and Spirogyra

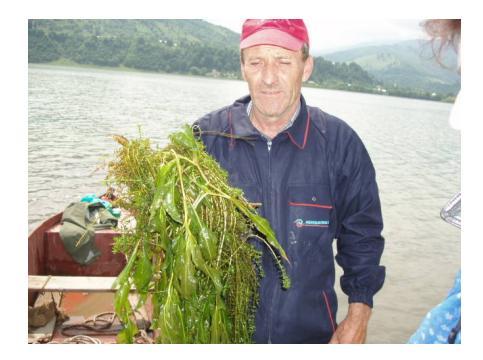
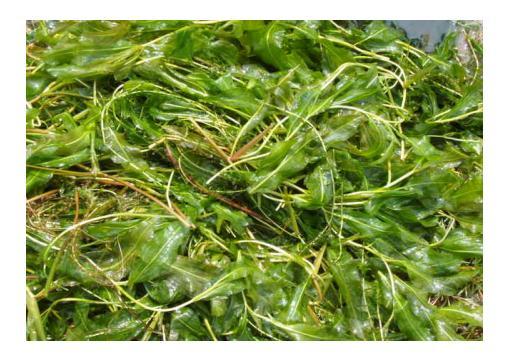
Fig. 2. Vegetation Recontruction Lake - Combined vegetation with Elodea

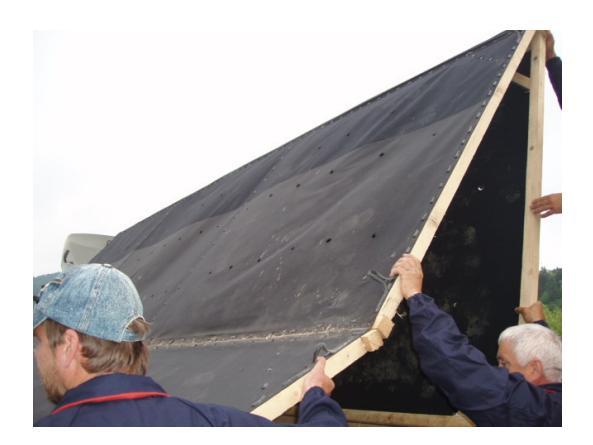
Barriers are formed by opaque materials, placed on bottom of lakes, over vegetation at the beginning of growing, March-April. In Fig.3 is presented an image with barriers before implementing into the Pangarati Lake.

Fig. 3. Image with barriers before implementation into the lakes

The barriers were realised as modulated solution to be easier to me manipulated, transported from one lake to another and to be installed. From the other country experience there were made some orifices to permit the evacuation of formed gases during vegetation destroying. The material must be elastic but do not be deformed during time. The orifices must be small enough not to let light to enter till vegetation and to let it to grows through orifices (in time will destroy the barrier) but large enough to let gases to be evacuated at the lake surface.

In Fig.3 may be observed a small amount of water placed over the barrier. Due to this fact the barrier practically flows on water surface and it is easy to be transported to final location.

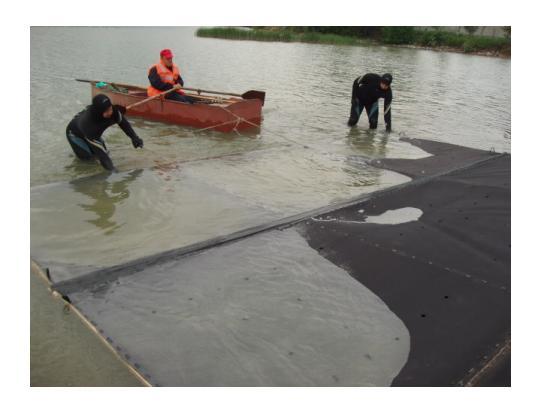
At the corners of the barriers are placed bags full of sand and rocks to keep the barrier exactly into the same position no matter flow rate into the channels.

Fig. 4. Picture during implementation into Lake Pangarati

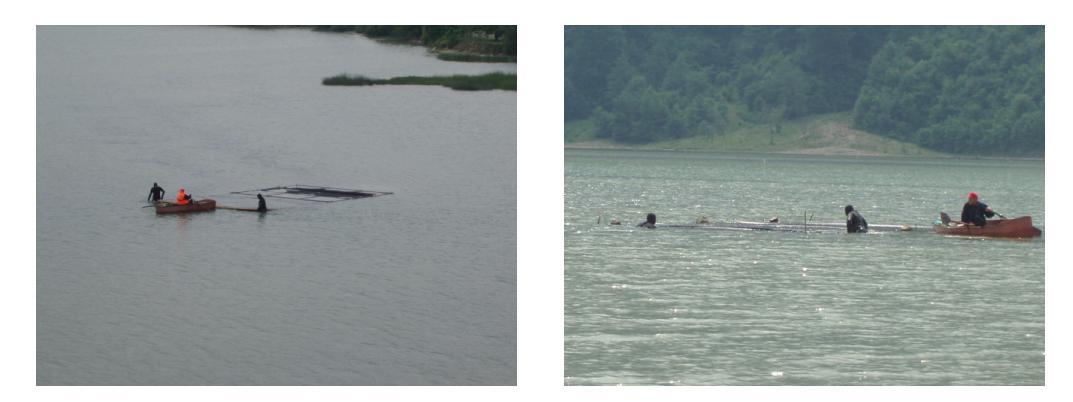
Fig. 5. Images during barriers anchoring

To be easier there are necessary at least two people; one to keep fixed the barriers and the other to put the anchor at the corners. It's very important that the barriers will rest necessary time till next move into the same position no matter flow rates (to be sure may be putted extra anchor to borders).

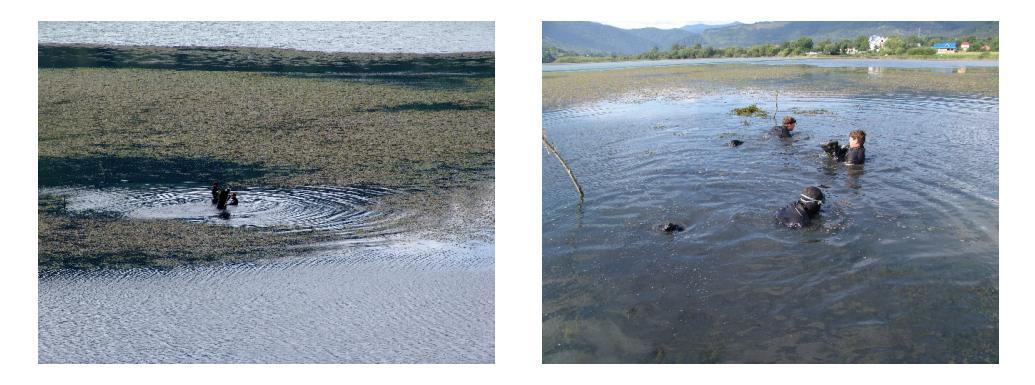
Fig. 6. Images proving the effect of barrier

In images from Fig.6 it's evident to explain the effect of barriers. The places were the barrier was placed rest as a small amount of water free of vegetation. The scuba divers team try to collect vegetation from places where the barriers where placed, but as it is shown into pictures from Fig. 7 and Fig. 8 it was impossible. Even if it was green the roots were all destroyed. At the border of the barrier the vegetation was only partial destroyed, Fig.7, but under them it was practically no vegetation, Fig. 8.

After the time passed even from the arrival at the barriers place it was observed that the colour of the water was changed. The anchors have been moved and the barrier took away, till next location. It appears like a clean portion on the water surface. The barriers were in good conditions, proper to other locations.

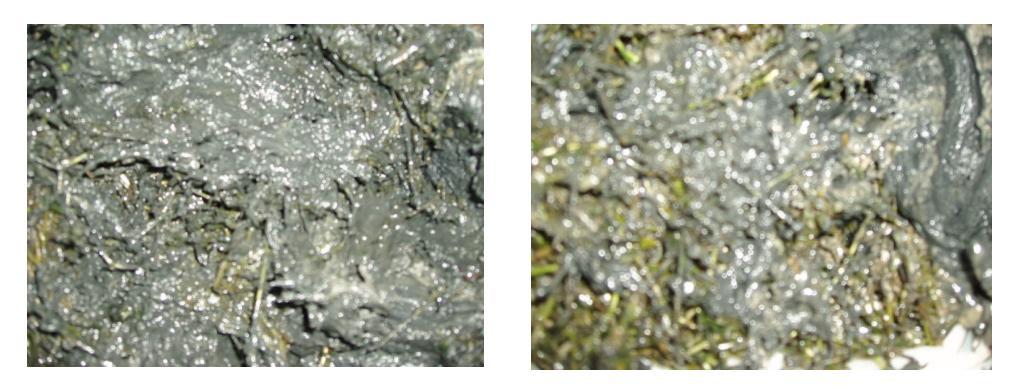
Fig. 7. Vegetation collected at the border of barriers; all roots are destroyed

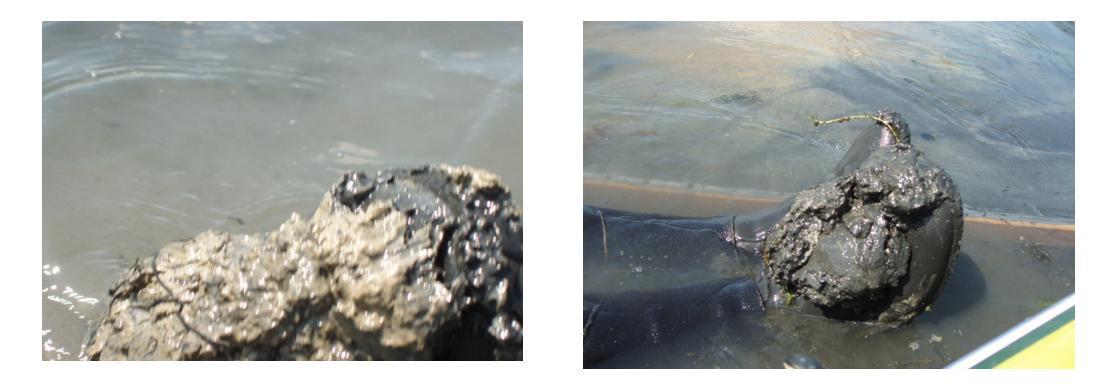
Under the barriers there is a sucking bad breath smelling like a real bank material into decay. The bank of the central area is more compacted then that one

from barrier borders. In to this one there is a supplementary amount of water.

Fig. 7. The bank from central part of barriers
